Learning from Earthquakes

Noto Peninsula (Japan) Earthquake of March 25, 2007

This preliminary report summarizes available information on the March 25, 2007, M_w 6.7 earthquake, and findings of a damage survey on April 1 in the high-intensity near-epicentral region. It was prepared for EERI by Shingo Nishida, Charles Scawthorn, Junji Kiyono, and Takahiro Tsutsumiuchi, all of Kyoto University. The publication of this report is supported by the National Science Foundation through EERI's Learning from Earthquakes Program, Grant #CMMI-0650182.

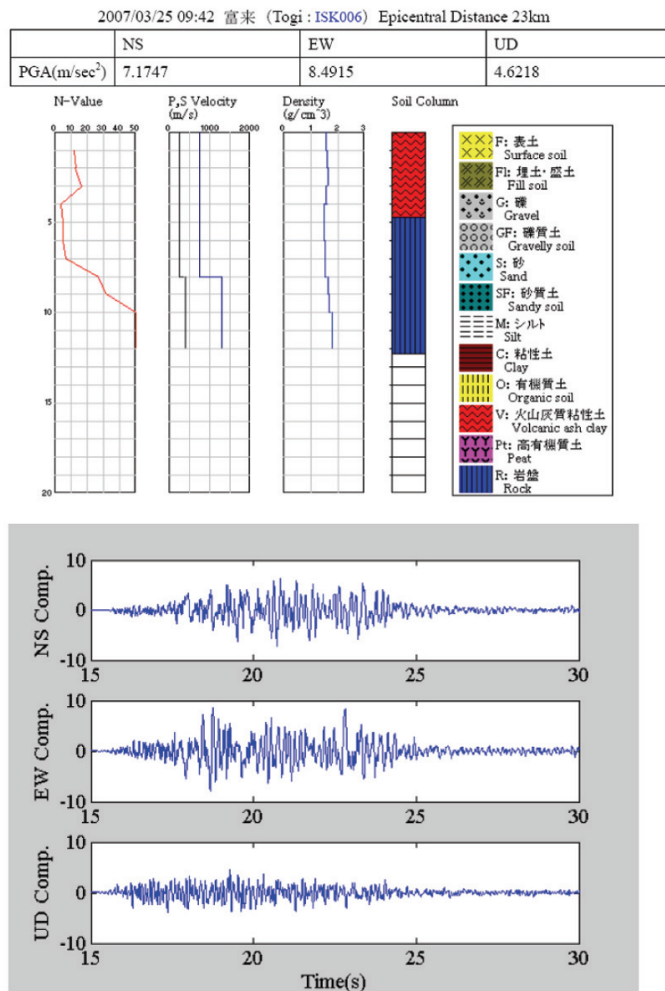
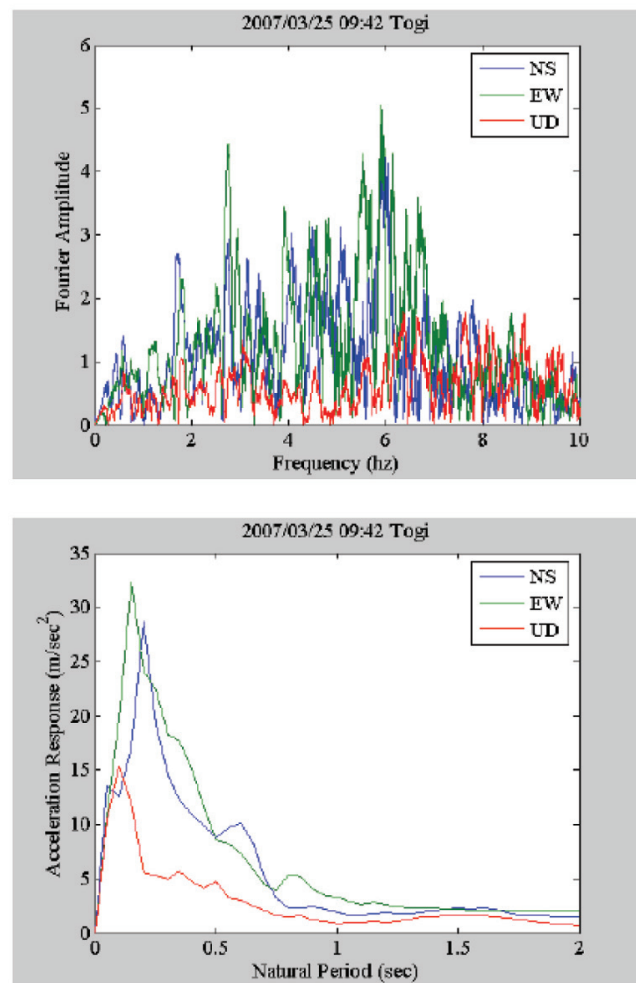
Figure 2. Togi site conditions, time history, Fourier amplitude spectra, and 5% damped response spectra (other records available at <http://www.kyoshin.bosai.go.jp/k-net/>).

recorded ground motions were quite high. Long-period effects were not evident. The maximum PGA was recorded at the Togi K-NET station, where a single maximum component of 849 gals (three vector component max PGA 945 gals) was observed. Figure 2 shows the site conditions, time histories, and Fourier amplitude and acceleration response spectra for this record.

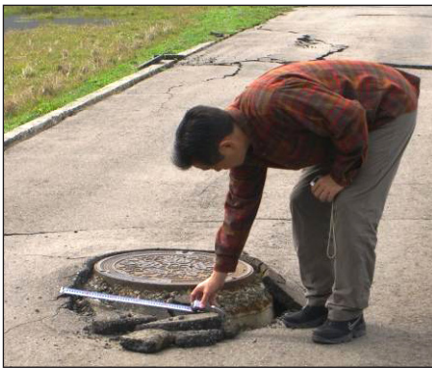
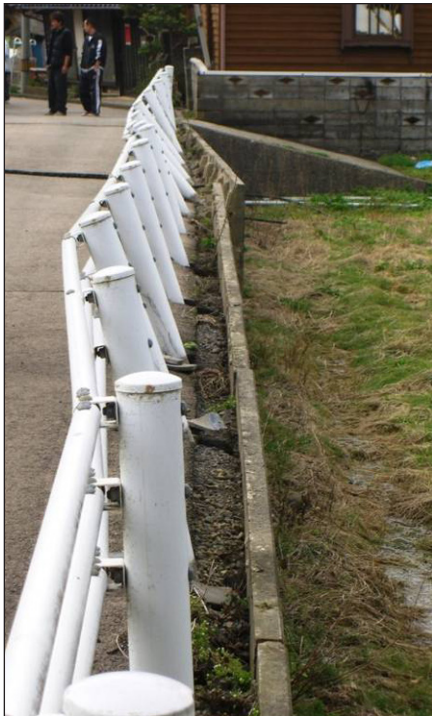
15 m height. No sand boils or other direct evidence of liquefaction were observed during our damage survey, although others reported finding such evidence (see Yoshida, 2007, where photographs of sand boils at Wajima port are presented). However, a number of manholes were observed to have “risen,” and indications of lateral spread were observed in a number of locations (Figure 3).

Figure 3. Lateral spread and man-hole deformation in minor roadway built over rice paddy, village of Doge (photos: Scawthorn).

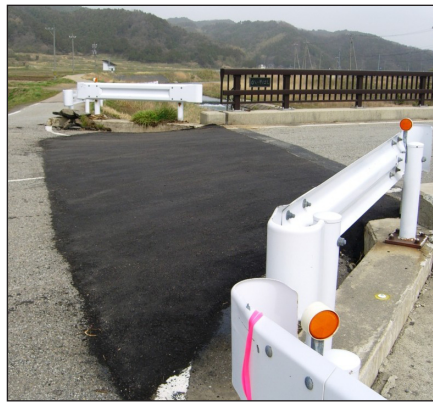
A lateral spread was observed along a river embankment in the village of Doge, and a bridge across the river about 50 m upstream had abutment settlements, but no other damage. Many other small bridges at various locations sustained similar abutment settlements, which were quickly repaired (Figure 4).

Figure 4. Bridge abutment settlement and temporary repairs to bridge in Doge (photo: Scawthorn).

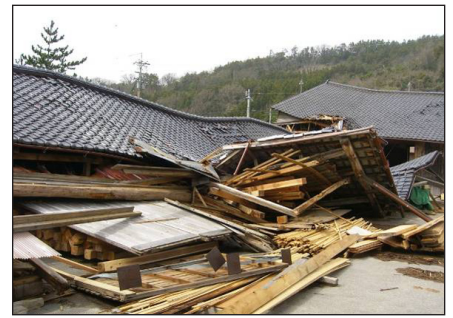
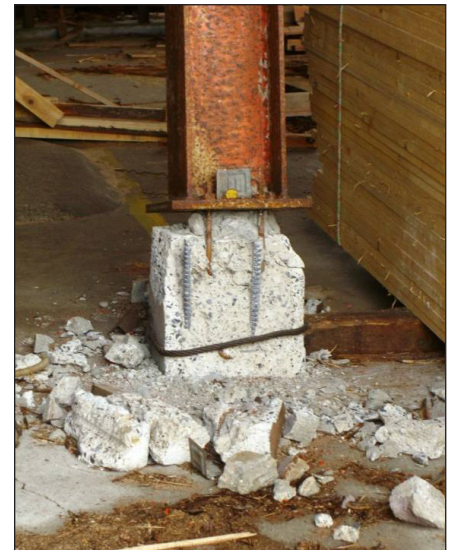
Engineered buildings. Despite the high recorded ground motions, engineered buildings generally performed well. An exception was an older steel-framed industrial shed building at a lumber yard in Doge, which collapsed (Figure 5). It had steel columns with tie rod bracing, wood secondary framing, and a heavy tile roof. Failure appeared to be due to shear in the single bolt connections of the tie rod bracing. Whether the building had actually been engineered is questionable.

Figure 5. Collapse of steel industrial building, Doge (photos: Scawthorn).

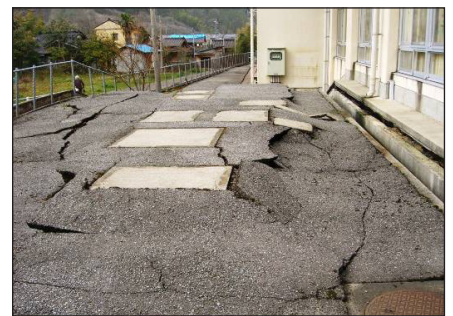
School and municipal buildings in Monzen (the closest location to the epicenter) typically performed very well. The worst problem appears to have been settlement and lateral spreading on the west side of the main building of the middle school, adjacent to a drainage channel (Figure 6). An intensity meter at this location registered IJMA 6+ (equivalent to MMI X). Several of these buildings had been seismically strengthened, and appear to have performed very well.

Figure 6. Monzen Middle School: ground settlements around underground tanks west of main building (photo: Scawthorn).

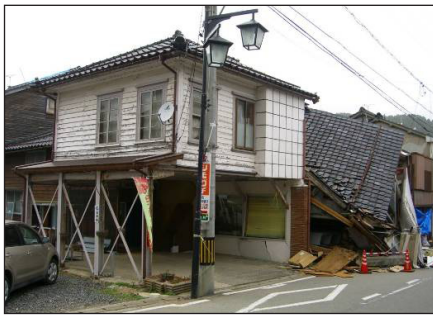
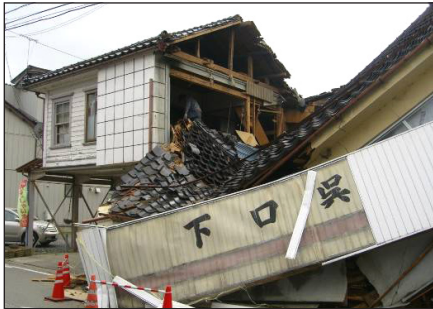
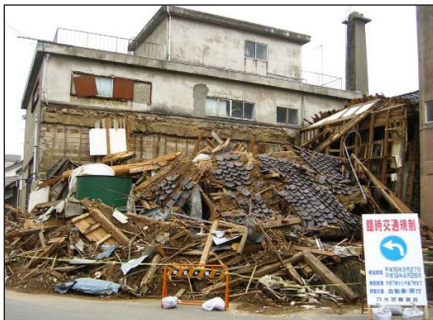
Figure 7. Monzen: (top) undamaged building, due to bracing; (middle) neighbor collapsed; (bottom) pancake collapse of traditional wood-frame house (photos: Scawthorn).
